Manhole Inspection Summary

Manhole # S29K1_013MH

Insp Date: **3/18/08 10:18 AM**

Location Address: **2200 Round Rd.** Cross Street: **na**

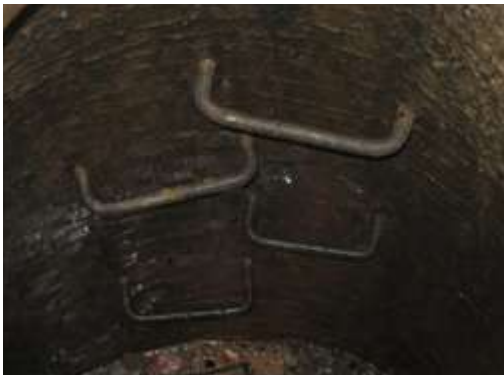
Steps Count: **4** Missing: **0** ☐ Corroded

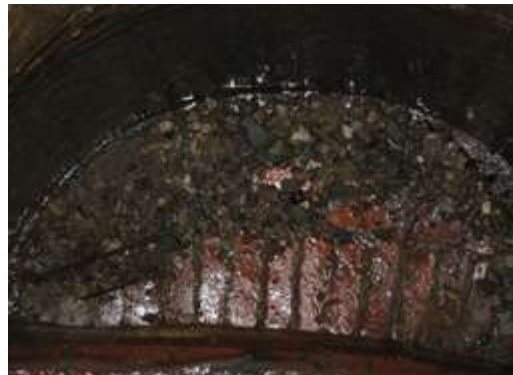
Defect 2

Debris

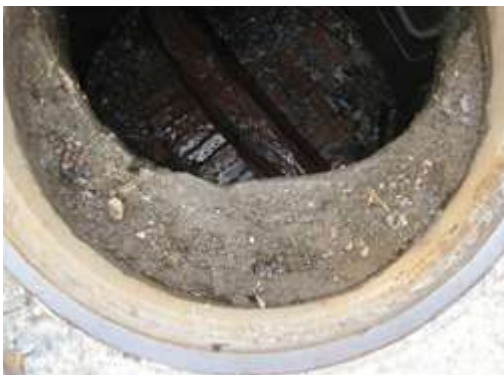
Defect 1

Frame Offset: **6** (in.) Condition: ☒ Sound ☐ Cracked ☐ Leaks

Frame offset

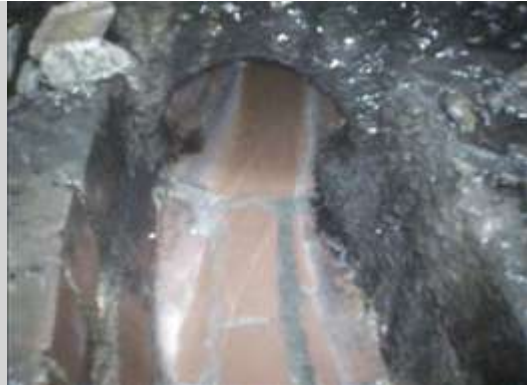
12 O'Clock Outflow

8 in. Circular Gravity Sewer
Pipe Out @ 12 O'Clock

Pipe Height: **8.4** (in.) Rod and Bar (Angled)

Pipe Material: **Clay** ☐ Pipe Lined

Invert Depth: **9.81** (ft.) Flow Characteristics: **Fast**

Infiltration: **None** Pipe Seal Cond: **Sound**

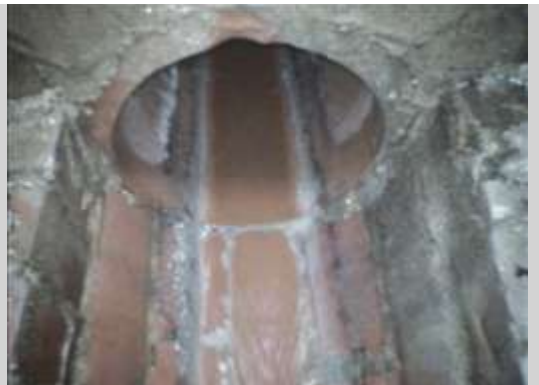
6 O'Clock Inflow

8 in. Circular Gravity Sewer
Pipe In @ 6 O'Clock

Pipe Height: **8.4** (in.) Rod and Bar (Angled)

Pipe Material: **Clay** ☐ Pipe Lined

Invert Depth: **9.52** (ft.) Flow Characteristics: **Fast**

Infiltration: **None** Pipe Seal Cond: **Sound**
